CASE STUDY

Kell Cottage

Heritage Listing: Victorian Heritage Register

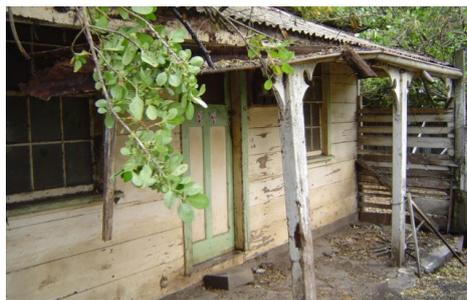
Top Kell Cottage seen through the period garden. **Centre** The 1840s cottage was derelict prior to renovation. **Bottom** The sitting room in Kell Cottage.

When purchased by the current owner, the small cottage was derelict. Since it was built (between 1847 and 1852), it had had only four owners. Minor alterations had been made over time, with some new surfaces and materials added, but very little had been removed. The new owner, a heritage architect, likens the property to a gracefully ageing older woman: “the surfaces were wearing, cracks and wrinkles were

showing and balances were stumbling.” The building fabric, tattered in places, evoked the life of the building over the previous 170 years. The materials – basalt rock on the surface for footings, timber mortice and tenon stud frame, and 25 x 270 mm tongue-and-groove weatherboard – were durable and robust, able to be repaired and revived while maintaining their character, quality and the heritage values embodied therein.

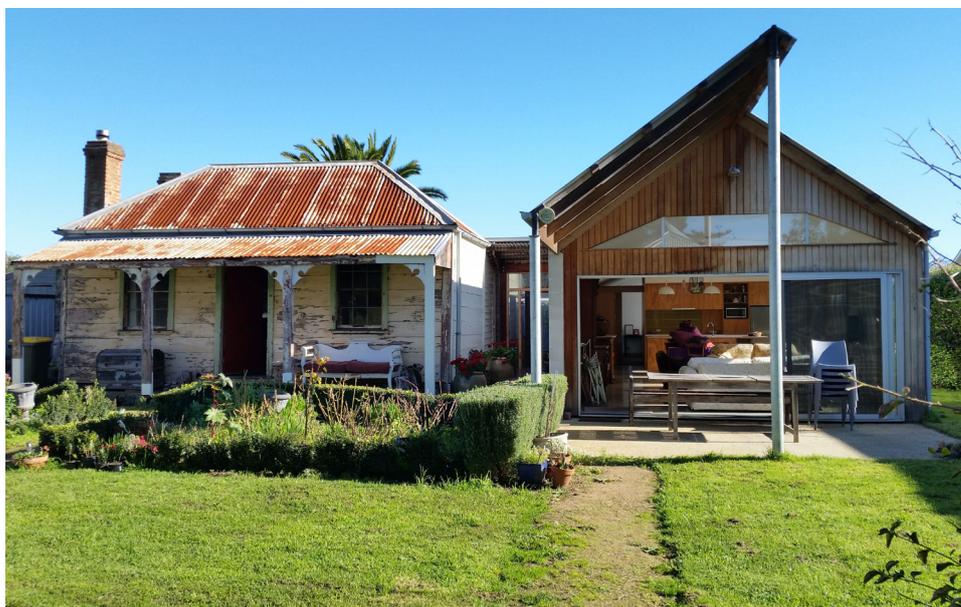
Top left The block is divided in two, on one side is the cottage and period garden, on the other the new addition in a simpler landscape setting.

The approach to site planning and the design of the alteration enables and supports this respectful care of the heritage fabric. The block has been conceptually split in two – on one side is the 1840s part, with cottage and a period garden in front, the other is clearly from the twenty-first century – a new, energy-efficient building surrounded by a simpler lawn, with a garage concealing it from the street. The new structure, containing living spaces, kitchen and a bedroom, runs parallel to the cottage and wraps behind with a sunroom, bathroom and laundry.

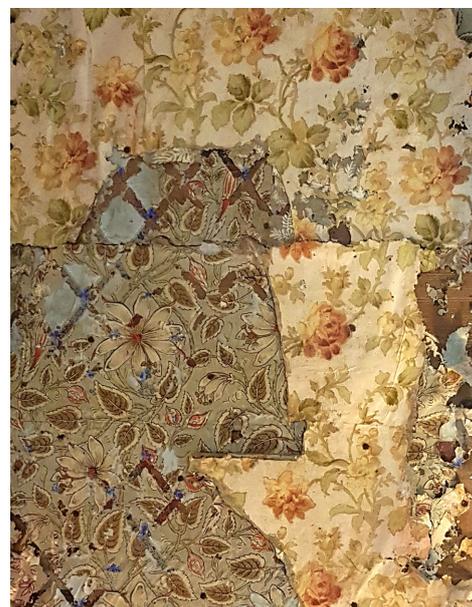
Top right Layers of heritage wallpaper have been kept in the house. **Bottom** The sunroom at the rear of the heritage cottage, with the cottage exterior wall visible on the left.

The cottage had 30 different wallpapers layered across the four rooms. These have been retained in some rooms, but in the front parlour a new layer of 1850 reproduction wallpaper has been added over the top, in a design that is very similar to the original second layer. A later bathroom had been slotted into place and was easily removed to reveal the earlier split lining boards.

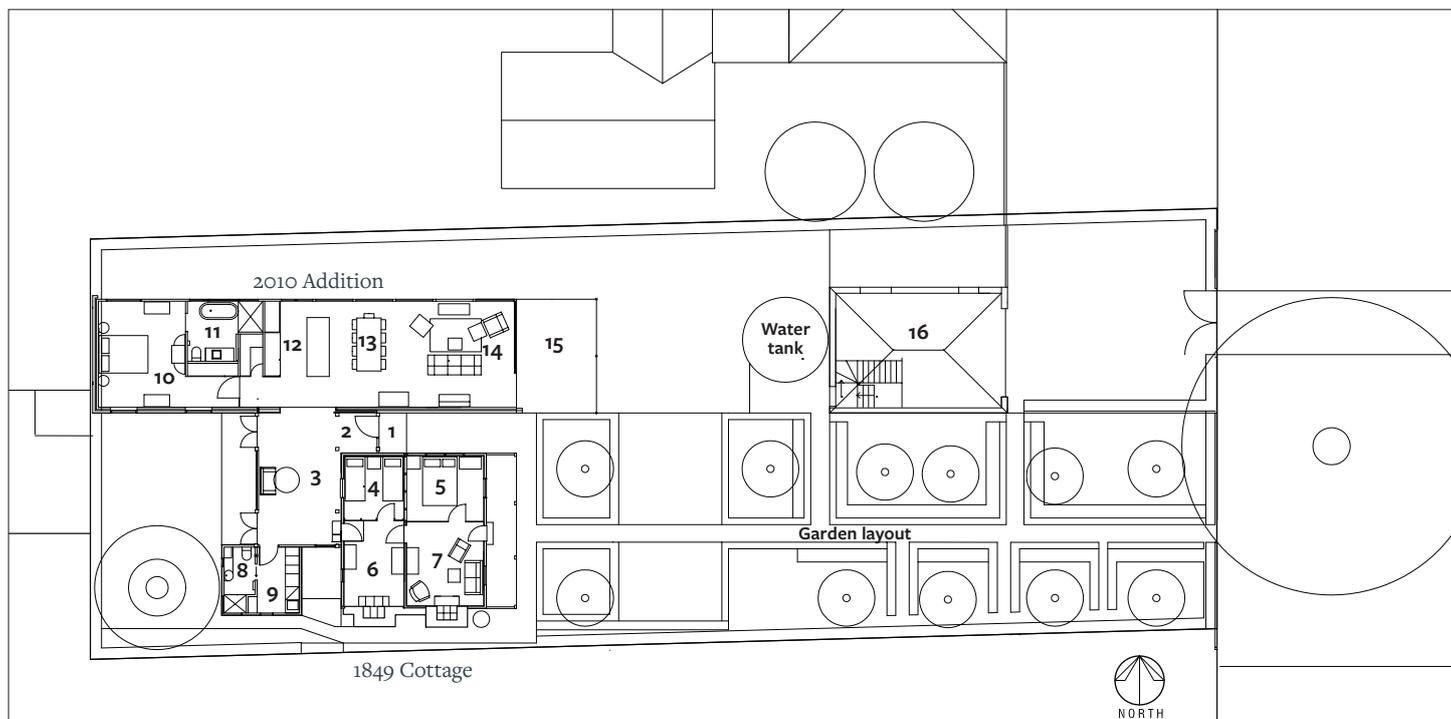
Site plan 1 Porch 2 Entry 3 Sunroom 4 Bedroom 5 Bedroom 6 Study 7 Sitting room 8 Bathroom 9 Laundry 10 Bedroom 11 Bathroom 12 Kitchen 13 Dining 14 Sitting 15 Porch 16 Garage with store room over
