Dow's Pharmacy

The place

Site vulnerability and heritage impacts

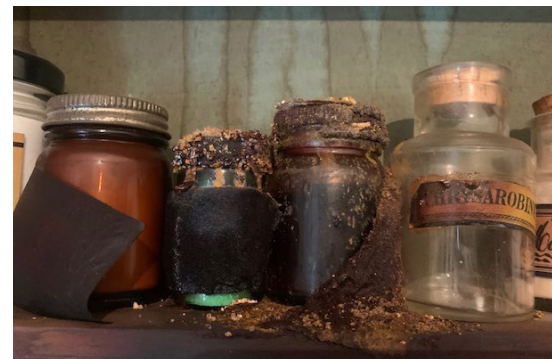
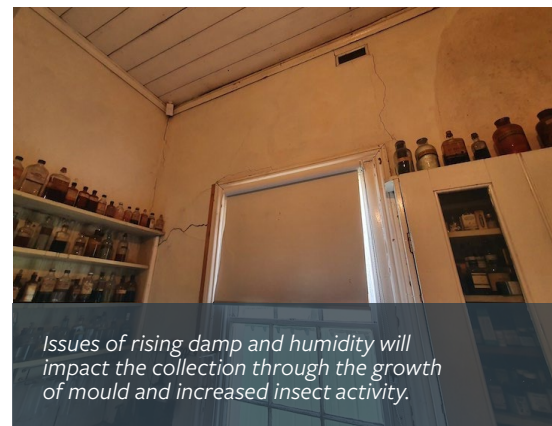
Issues of rising damp and humidity will impact the collection through the growth of mould and increased insect activity.

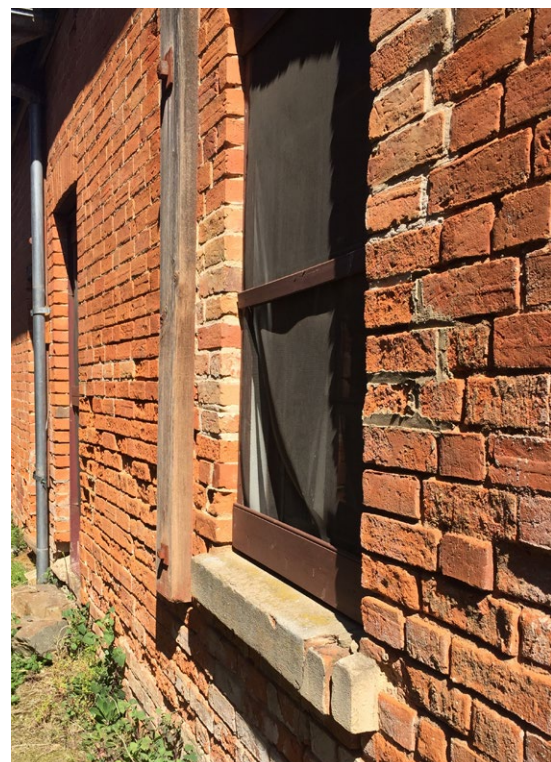
Rising damp and humidity carry more salts up into the brickwork. Salts on the wall surfaces will result in more rapid decay of the soft, porous brickwork.

- improving drainage or other works to prevent oversaturation of the soil around the building, in consultation with local authorities
- replacing guttering and downpipes with a larger-capacity system to prevent further decay of the building
- repairing structural cracking and desalting and repointing fragile brickwork
- reducing the risk of rising damp, salt attack and subfloor flooding by lowering the surrounding ground level
- removing or replacing impermeable cement renders, coatings and other fabric with permeable materials
- coating the exposed western wall with permeable limewash to improve weather protection

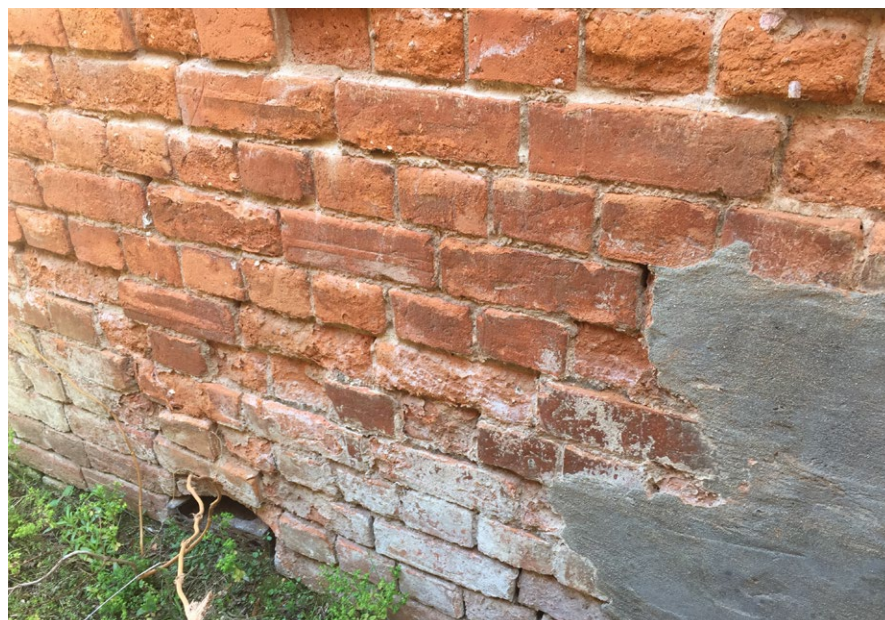
Drainage issues at the base of the building will result in movement in the shallow stone footings and consequent cracking of the walls.

- commissioning conservation documentation to scope funding for improvement works
- installing air-conditioning to dehumidify the interior
- restumping the building.
