# Point Cook Homestead and Stables

**Point Cook Homestead is a single-storey, largely bluestone house built in stages from about 1857 for pastoralist Thomas Chirnside. It is surrounded by a large garden. A semi-detached weatherboard wing of the house may be an earlier structure dating from 1849. Substantial bluestone stables were erected before 1861 and are part of a complex of buildings on the site.**

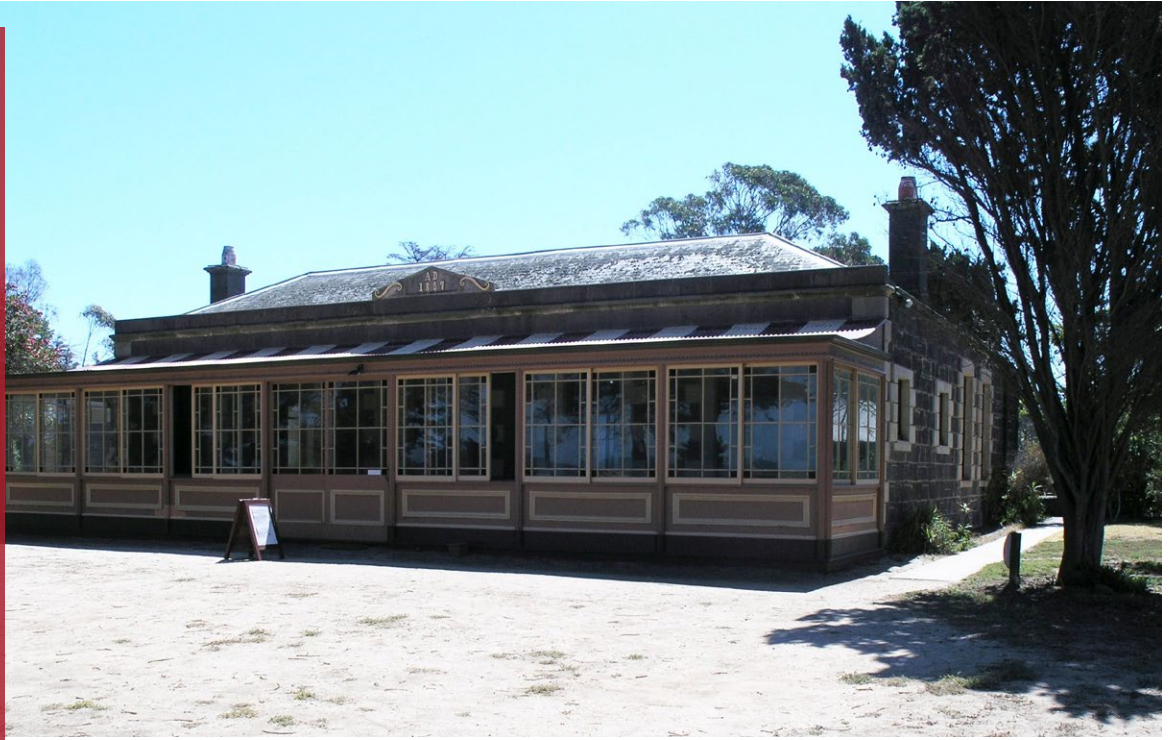
Front elevation of the homestead. (Image: Heritage Victoria)

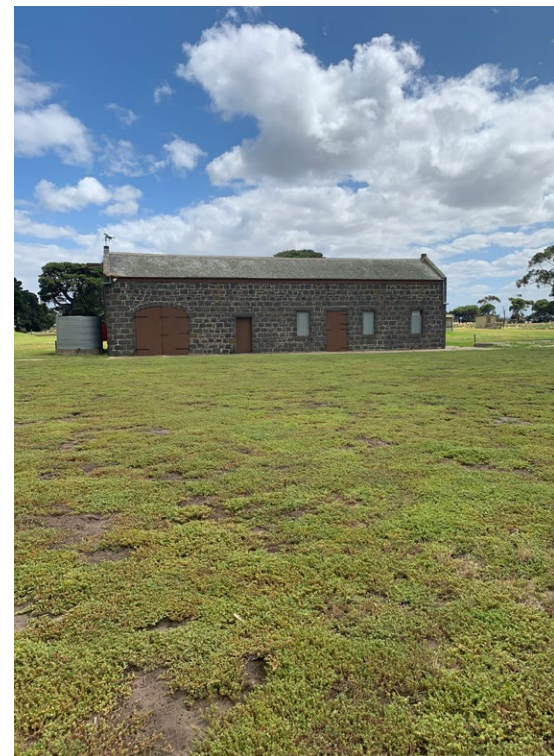
Structures in poor repair will also be more vulnerable to wind impacts, as roofs may blow off, particularly where fixings and sheeting are corroded by the salt environment. There will also be a greater likelihood of structural damage

View of stable building. (Image: Parks Victoria)

to the heritage buildings due to tree falls and wind-borne debris.

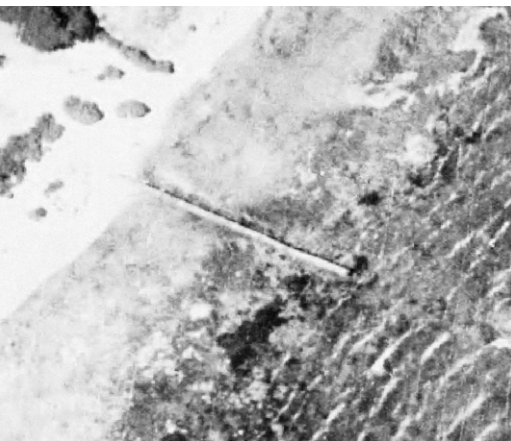
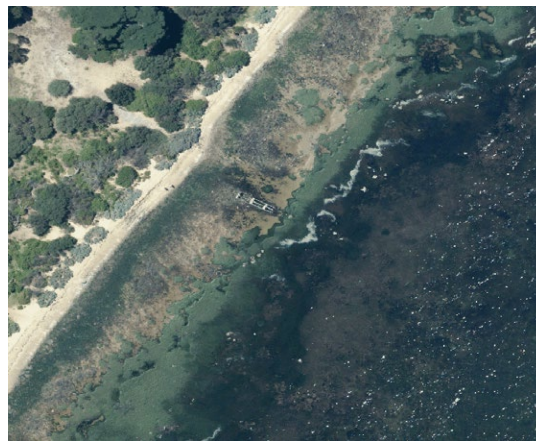
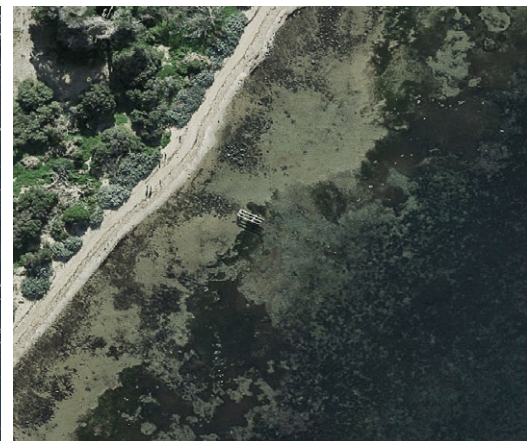
Some remnant fabric of the jetty has been lost in recent decades. The following images show the jetty in 1951 (left), 2011 (middle) and 2020 (right). Remnant archaeological remains are especially vulnerable to storm surges and sea-level rise. (Images: DTP VicPlan web map)
