Rippon Lea House and Garden

The place

Climate change impacts

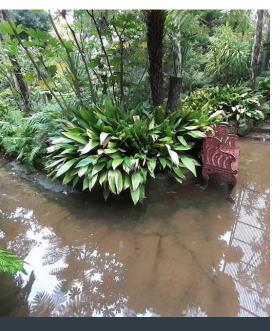
Excessive run-off and flooding may damage pathway and driveway surfaces, the irrigation system, and trees. Trees are more likely to fall in high winds, particularly when the soil is saturated.

Flood damage after a severe storm.

Targeted maintenance is a fundamental part of the National Trust's strategy for the property. The historic stormwater drains have recently been re-lined and are now coping well with water received on site. Documentation and recordkeeping for the site is also improving. For example, paper-based gardens data was recently transferred to a digital format.

- planting species that are adapted to the predicted long-term climate for Melbourne
- maintaining the original drainage system around the basement and not storing important collection items in this area
- investigating alternatives and providing improvements to roof drainage and discharge to cater for increased roof drainage flows
- maintaining natural ventilation to buildings
- insulating the roof space and upgrading heating and cooling systems to maintain suitable environmental conditions inside the building to protect heritage wallpaper and interiors
- adding fabric awnings to north and west facing windows where appropriate.

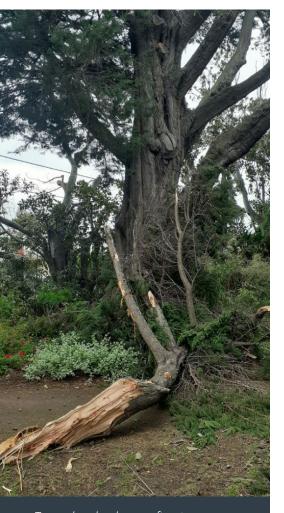
Tree and garden damage after storms.

Tree succession planning is also under way. Preliminary research on suitable species is available but existing and emerging research will be used to inform future succession planning.
